# Case Study

## Lennox Point, NSW

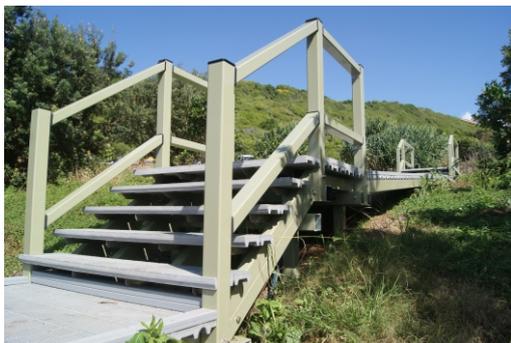
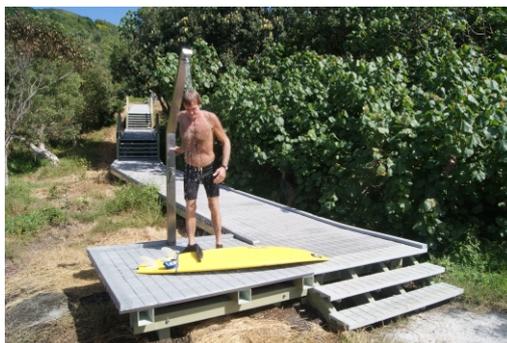
The solution was a 100-metre composite fibre and Enduroplank™ staircase and boardwalk that runs from the car park to the water's edge. The structure contains no wood with all components, including the sub-structure, made from either recycled plastic or composite fibre. Having the track off the ground protects surrounding vegetation while also keeping people away from the fauna of the area. The surfers love the slip-resistant surface and are extra pleased with the addition of a shower platform.
